CLIENT: The North Central Catchment Management Authority (NCCMA)
PROJECT: Flood Recovery Programme
DATES: September 2011 – December 2013

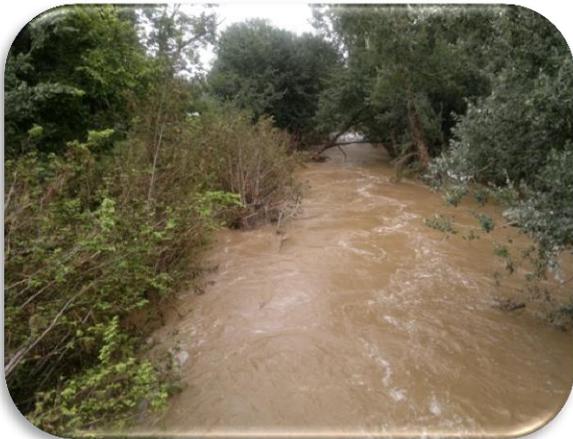
Creswick Creek flooded and surrounded by woody weeds

Only few weeks after the floods, Platypus engaged in the clearance of the creek's banks from woody weeds and overgrown vegetation to enhance the river's flow capacity and to prevent current-washed debris from causing obstructions at times of high discharge. Cut and paint methods were used on large trees to inhibit regrowth and were subsequently disposed of by means of a chipper.

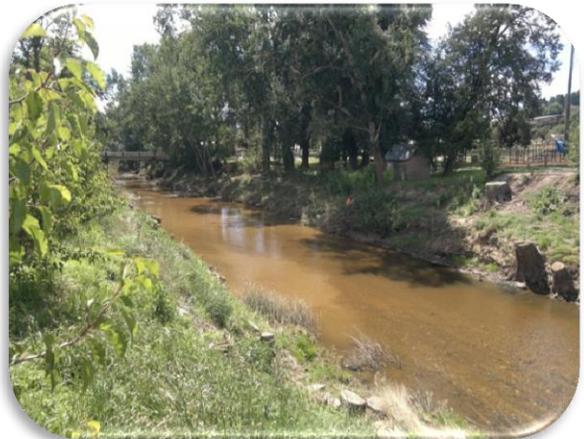
Creswick Creek banks are cleared

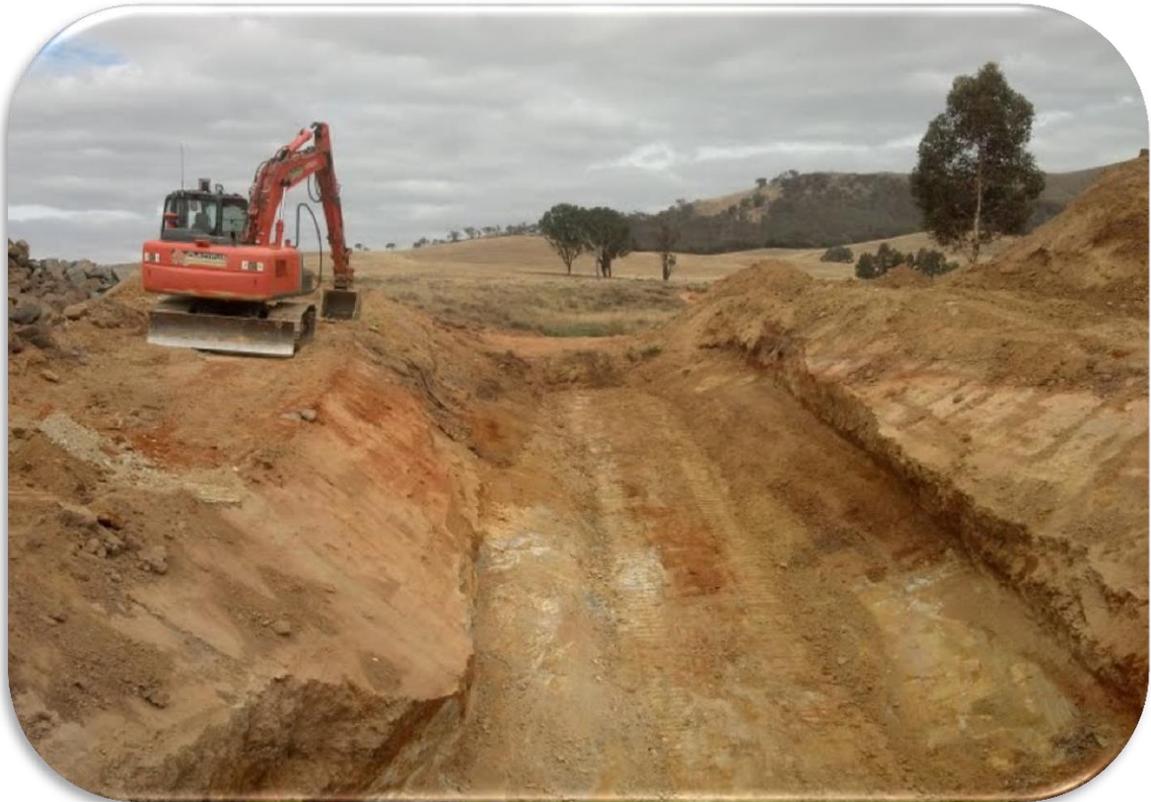
Erosion structures created with precision

In February 2012, Platypus started developing flood control systems around Heathcote. In the space of two months, five state-of-the-art water and erosion control structures including levees, gullies and rock chutes were created using excavators.

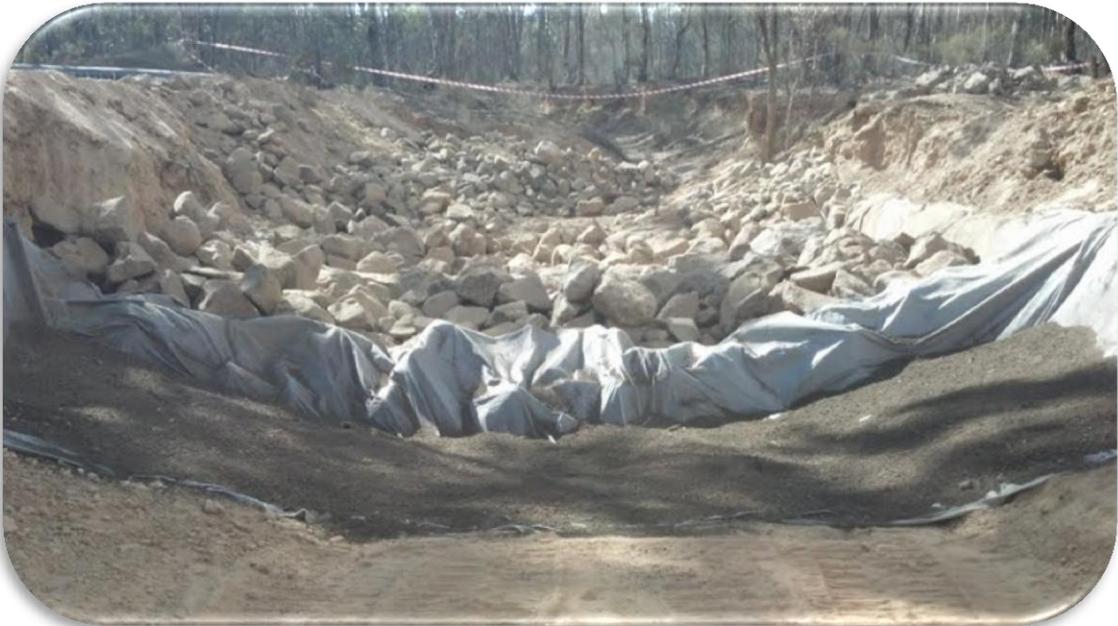
Usage of geo-fabric layup as sediment cut-off within rock chute

As part of the second phase of the Erosion Control Program more rock chutes, levees and gullies were created within the aforementioned areas to protect a number of sensitive sites. This was perhaps the most challenging and laborious phase of the project, which was successfully completed in eight months.

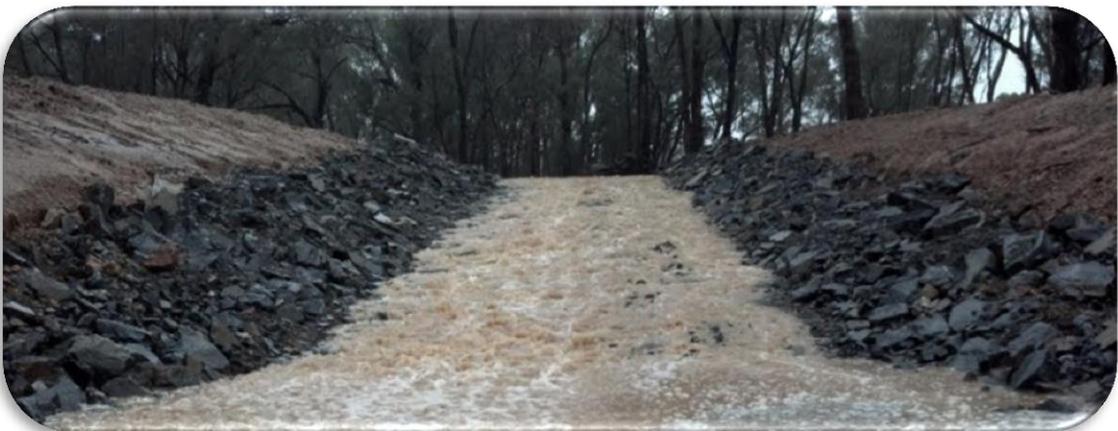
Rock chute working perfectly after heavy rainfall
